TOPIC Brandis Airfield

Brandis Airfield

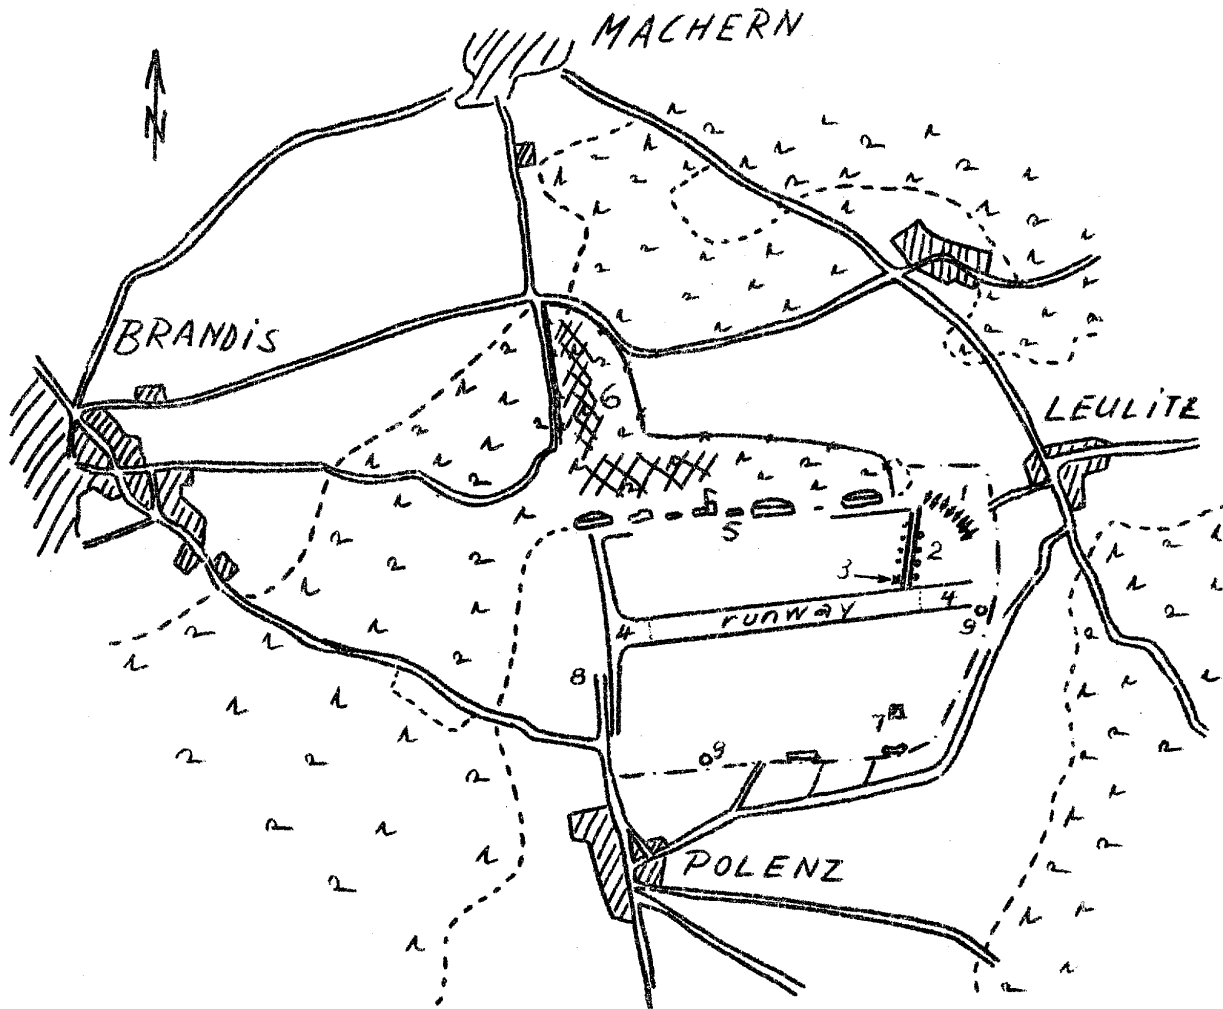
* Comment. For sketch of airfield, see Annex. The sketch, which seems credible, indicates that the runway is 1,900 meters long. The former runway was extended to the east and west.

- 1 - Parked jet fighters
- 2 - Taxiway with sand heaps on both sides
- 3 - Red sheet metal flag
- 4 - Ends of runway of light color
- 5 - Buildings, including three hangars
- 6 - Barracks installations
- 7 - Small bunker
- 8 - Road, completely removed 100 meters north of junction road to Brandis
- 9 - Sentry
